Pre-Purchase Building & Timber Pest Inspection Report

In accordance with Australian Standard AS 4349.1 - 2007 and AS 4349.3-2010

Premium Building and Pest Inspection - 01 TBI | Pre-Purchase Building & Timber Pest Inspection Report 2026

15 Jun 2026

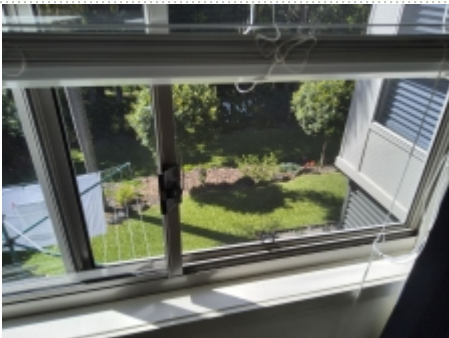
Upper level windows with no fall prevention. Recommend rectifying to meet to current standards and to reduce the risk of people falling out of the windows.

While this item represents a non-compliance with modern building standards and poses a safety risk, it is reported here to ensure it is not overlooked. The client must manage this risk as a priority.

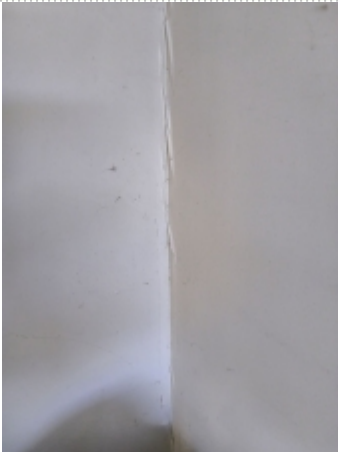
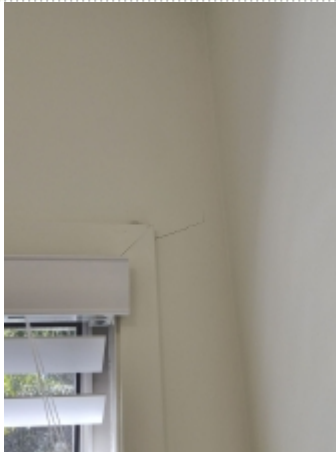
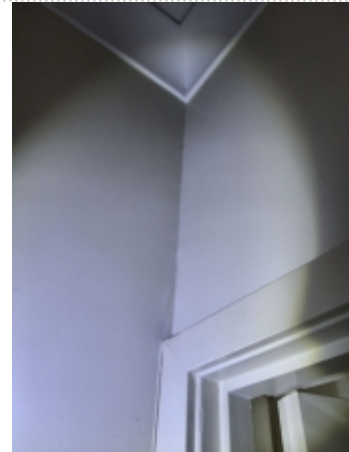
Details and Recommendations: Settlement/movement cracks to walls - recommend engaging a plasterer to rectify to prevent further deterioration

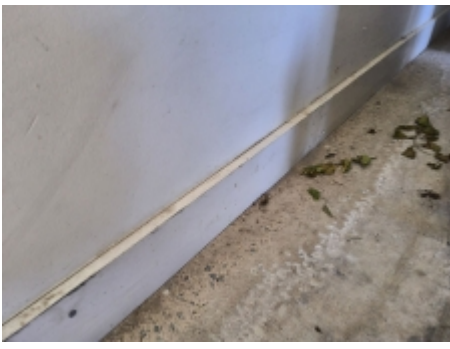
Details and Recommendations: Termite damage to skirting boards, recommend engaging a builder to rectify/replace once termites have been eradicated

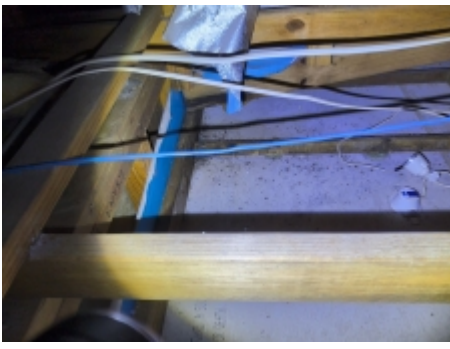
Details and Recommendations: Evidence of water leaks to parts of the roof. Recommend engaging a roofer to investigate further and rectify as necessary to reduce the risks of further leaks and damage.

No elevated moisture detected at the time of the inspection.

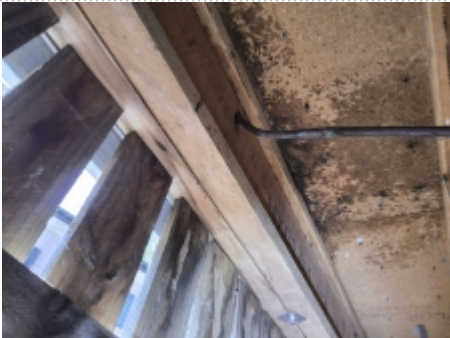
Details and Recommendations: Evidence of water staining/damage to sub-floor timbers. Recommend engaging a builder to do an invasive inspection to determine cause of leak and rectify as necessary to prevent further deterioration.

No elevated moisture detected at the time of the inspection.

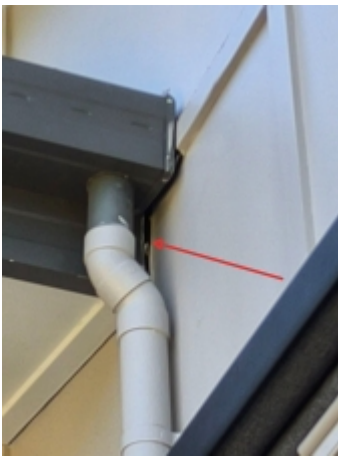
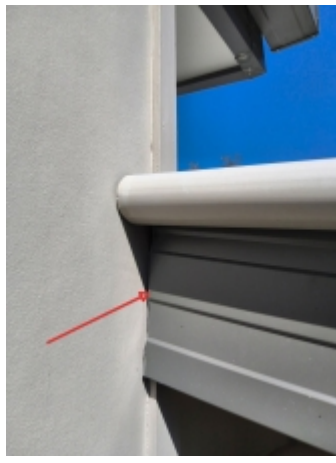
Details and Recommendations: A few gaps/cracks to exterior walls. Recommend engaging a builder or suitably qualified person to rectify/seal the areas to reduce the risk of water ingress and subsequent moisture damage.

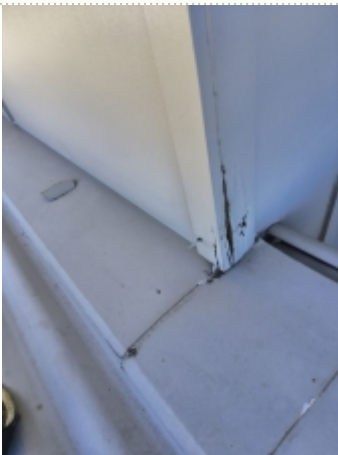
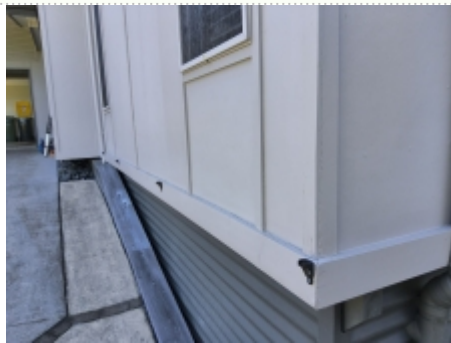
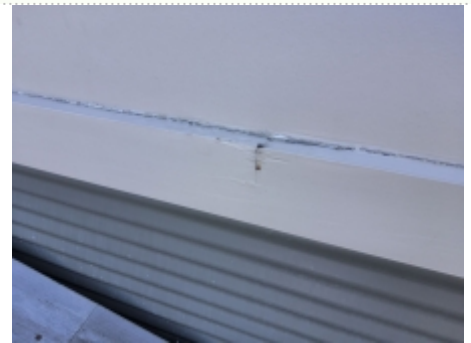
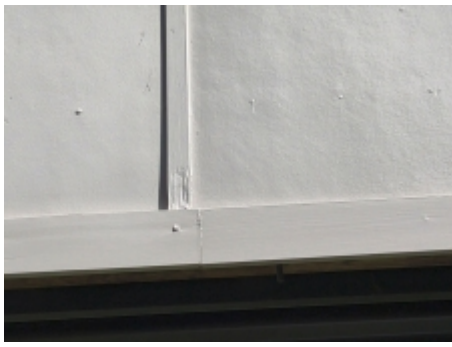
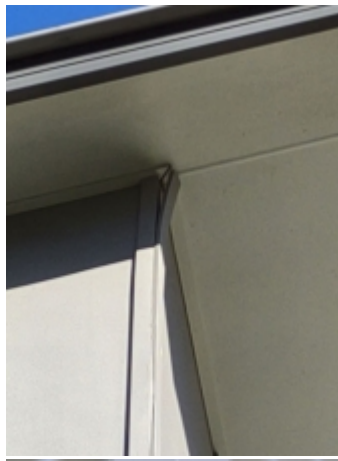
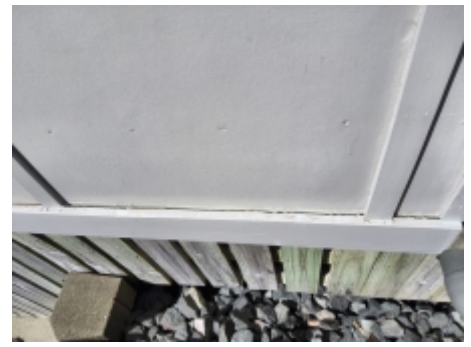
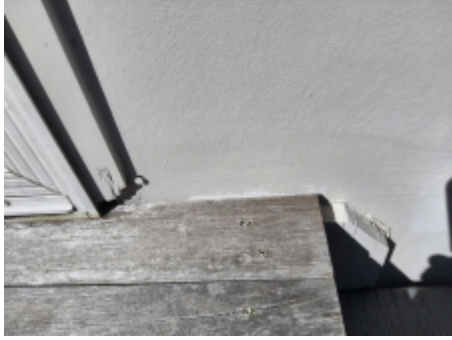
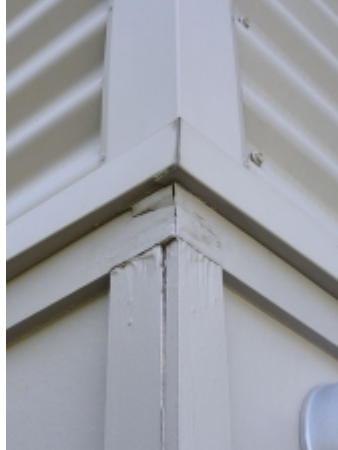
Wood rot to parts of timber trims. Recommend engaging a builder/painter to repair/replace to prevent further deterioration.

Loose timber trims, recommend engaging a builder and painter to rectify to make secure and prevent further deterioration

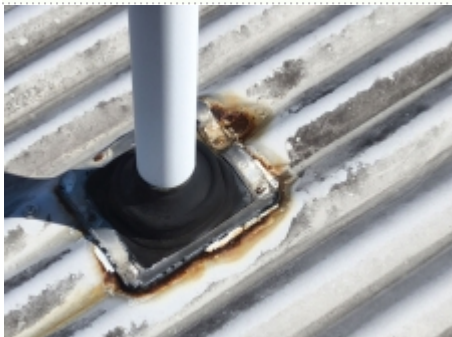
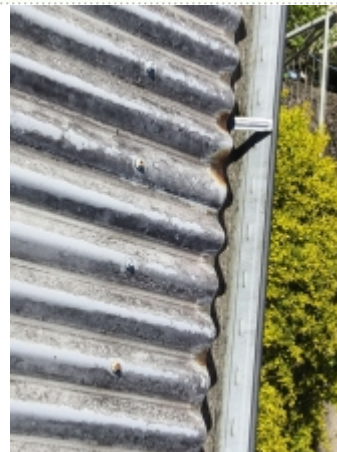
Location:	Around vent pipe above kitchen and ends of sheets
Details and Recommendations:	Rust to parts of the roof. Recommend engaging a roofer/painter to repair/replace to prevent further deterioration and to reduce the risk of water ingress into the building.

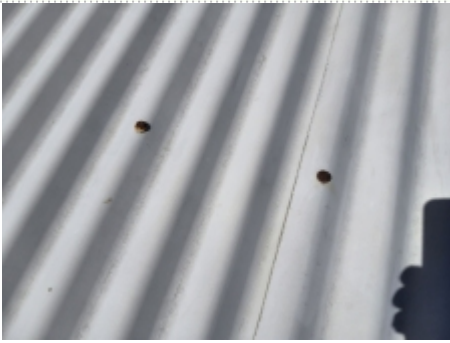
Location:	Approximately 10%
Details and Recommendations:	Rusting screws/fixings to roof. Recommend engaging a roofer to replace to prevent further deterioration and rust spreading to roof sheets.

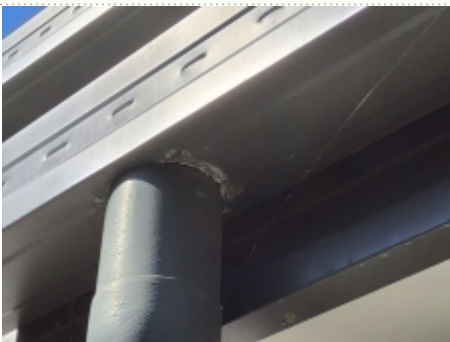
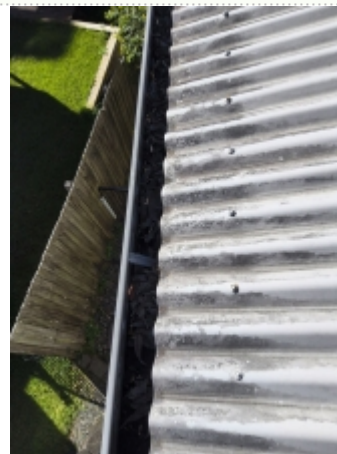
Location:	Various locations
Details and Recommendations:	<p>Debris to parts of the gutters/valleys. Recommend cleaning out to reduce the risk of rust and the gutters overflowing into/towards the building.</p> <p>Recommend keeping trees trimmed back from the house/roof.</p> <p>Rusting out down pipe droppers. Recommend engaging a plumber to rectify/replace to prevent further deterioration and make watertight.</p>

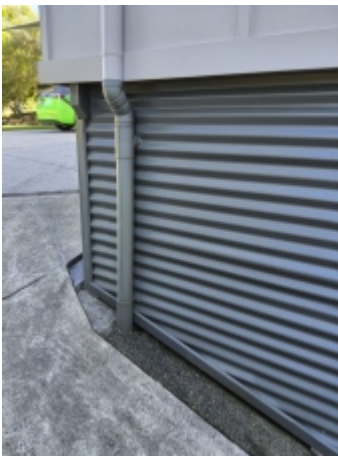
Location:	South End of house
Details and Recommendations:	Leaking downpipe/s, recommend engaging a plumber to rectify to make watertight and reduce the risk of moisture related issues.

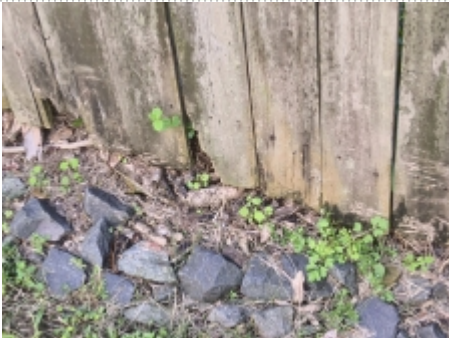
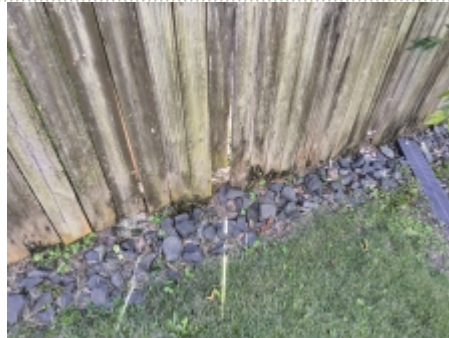
Wood rot/fungal decay to fence/s. Recommend engaging a fencer/landscaper to rectify to prevent further deterioration.

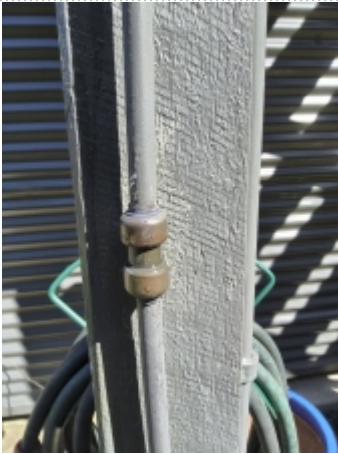
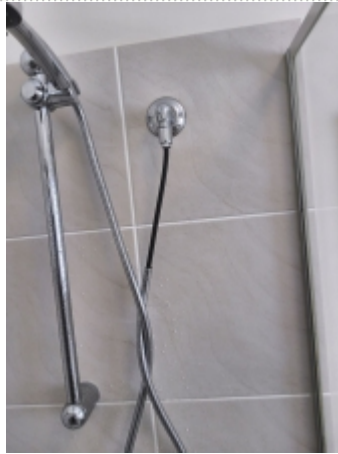
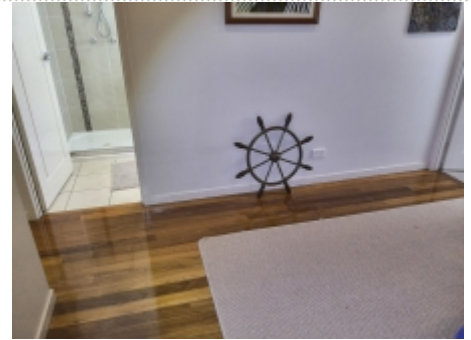
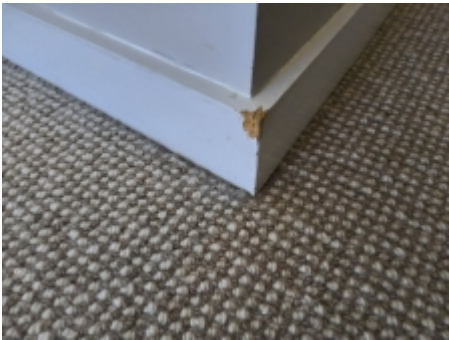
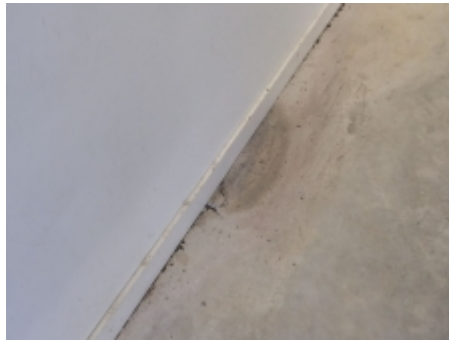
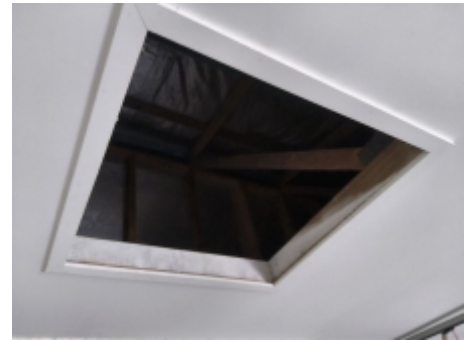
Minor settlement/movement cracking to interior walls

Minor plaster/paint defects

Minor damage to parts

Minor corrosion to parts

No man hole cover in garage

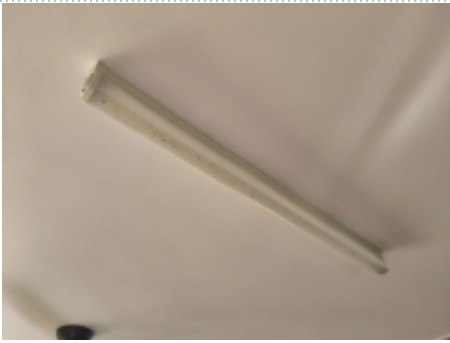
Details and Recommendations: No bulb in one of the fluorescent lights.

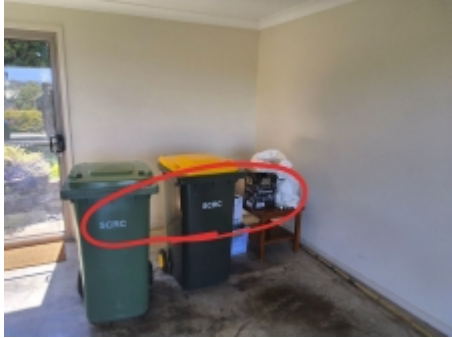
Was evidence of termite workings or damage found?	Yes
The extent of any visible damage appears:	Localised

Location:	Termite damage to finishing timbers. Rear of garage
Details and Recommendations:	Recommend replacing all damaged timbers. Recommend treating all live termites. Recommend further invasive inspection to the framing around areas of termite workings to determine if there is any concealed damage.

Due to the presence of structural timber pest damage, a licensed builder or structural engineer must be engaged immediately to assess the structural integrity of the building components and perform necessary rectification work.

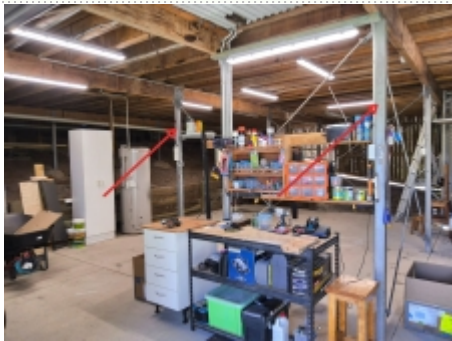
Date of Treatment: (if known)	13 Jun 2006
The following evidence was found:	Evidence of steel stumps.

Details and Recommendations:	Recommend installing a suitable Termite Management System immediately to reduce the risk of termite attacks.
	No physical termite barrier sighted at the time of inspection

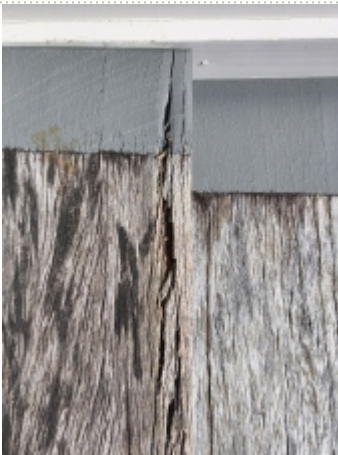
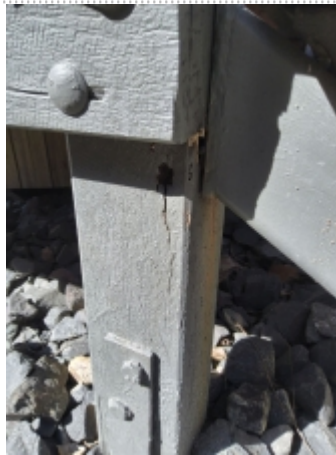
Visible damage appears to be located in the following areas: Deck Timbers

Details and Recommendations: Recommend replacing all damaged timbers.

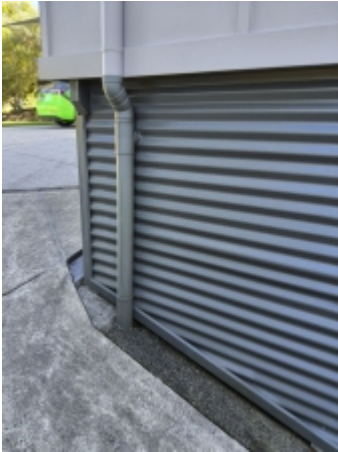
Were water leaks found at the time of inspection?	Yes
Visible leaks were located in the following areas:	Down Pipes
Details & Recommendations:	Recommend engaging a plumber to repair the leak/s.

If leaks are detected, it is recommended that a suitably qualified plumber or builder is engaged to rectify as soon as possible.

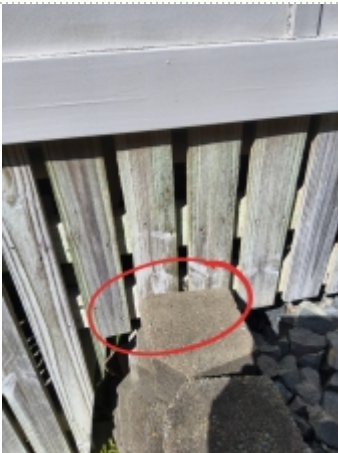
Location: Northern end of house

Details & Recommendations: Timbers in contact with the ground, recommend exposing 75mm below all timbers to reduce the risk of termite attacks and other moisture related issues
