Pre-Purchase Building & Timber Pest Inspection Report

In accordance with Australian Standard AS 4349.1 - 2007 and AS 4349.3-2010

Premium Building and Pest Inspection - 01 TBI | Pre-Purchase Building & Timber Pest Inspection Report 2026

15 Jun 2026

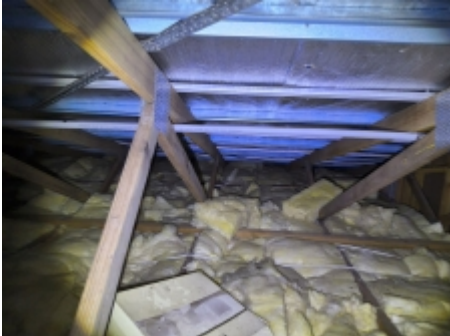
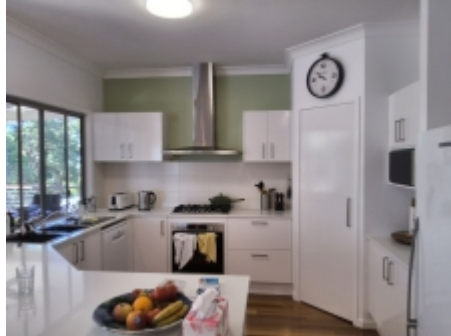
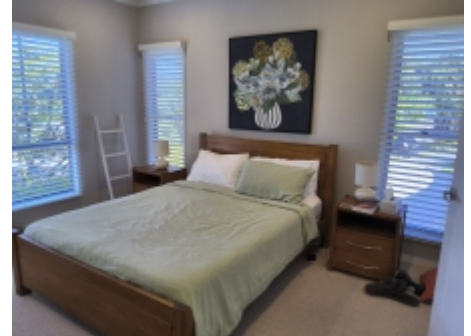
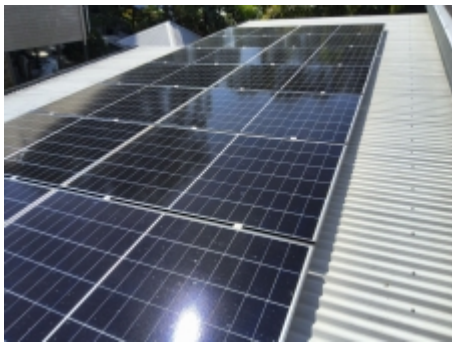
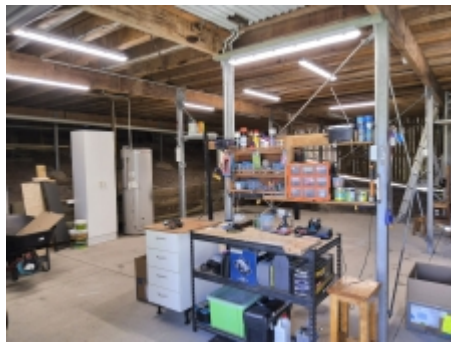
Showing Examples of Obstruction Photos

- External fixtures.
- Landscaping and gardens.
- Cabinetry.
- Window furnishings.
- Furniture and stored items throughout.
- Framing and low clearance in roof space.
- Insulation to the roof space.

It is important to note that as an inspection of the above areas was not possible at the time of the inspection, defects, timber pest activity or damage may therefore exist in these areas.

It is very important to note that further inspection is highly recommended for any areas where access or visibility was hindered, restricted or obstructed in any way at the time of the Inspection.

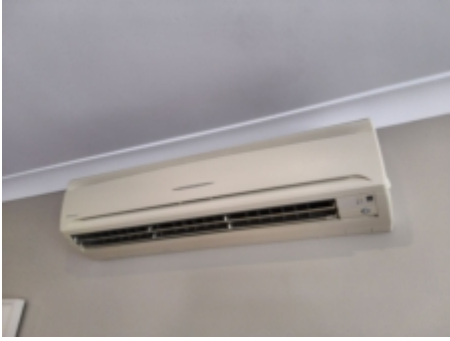
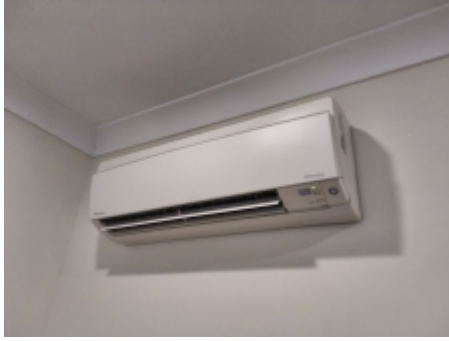
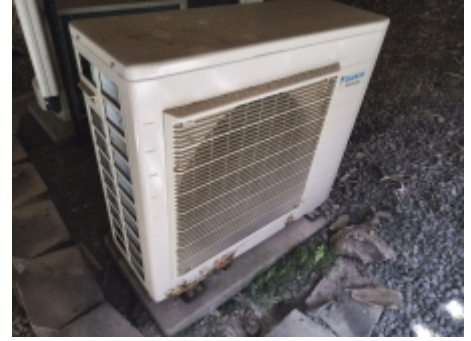
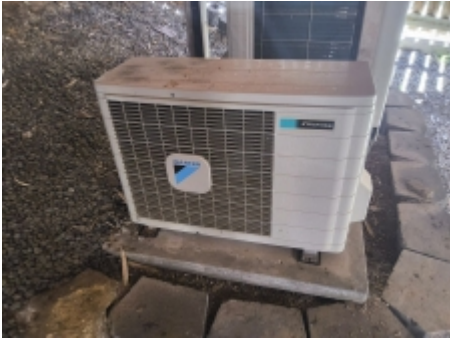
P.3 Air Conditioning **No evidence of air conditioning defects was found**

Below are context images of the operational check performed on the (System). This was a basic, non-invasive visual overview only. No visible operational faults were noted at the exact time of inspection, but this does not imply compliance or long-term safety.

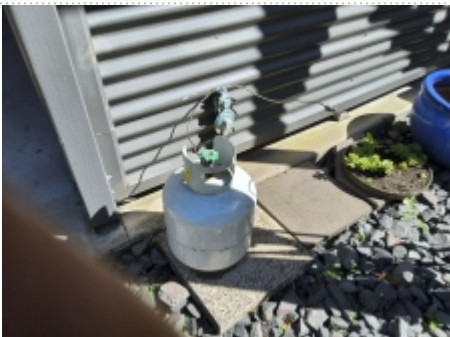
P.4 Gas

No evidence of gas defects was found

Below are context images of the operational check performed on the (System). This was a basic, non-invasive visual overview only. No visible operational faults were noted at the exact time of inspection, but this does not imply compliance or long-term safety.

We are not licensed gas fitters; this is a simple on/off test of gas fittings and fixtures. We recommend engaging a licensed gas fitter to investigate further for a full gas audit.

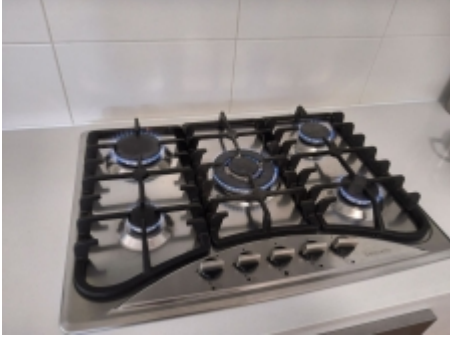
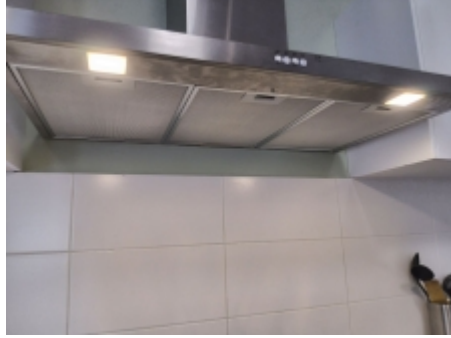
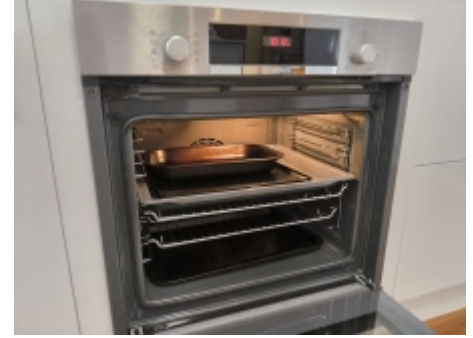
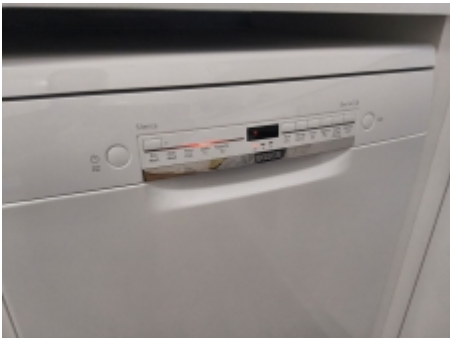
P.5 Appliances

No evidence of appliance/s defects was found

Below are context images of the operational check performed on the (System). This was a basic, non-invasive visual overview only. No visible operational faults were noted at the exact time of inspection, but this does not imply compliance or long-term safety.

We are not licensed electricians; this is a simple on/off test of appliances. We recommend engaging a licensed electrician to investigate further for a full appliances audit.

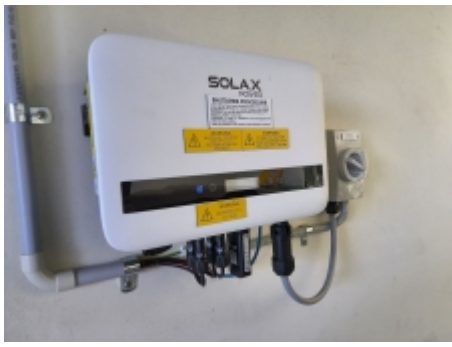
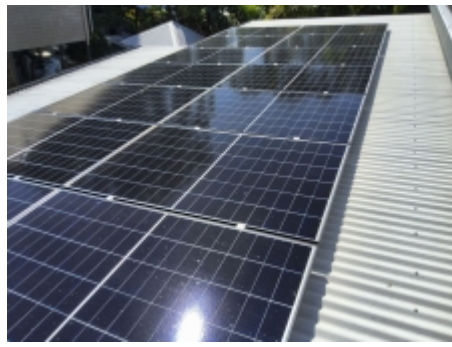
P.6 Solar

No apparent evidence of Solar defects was found

Below are context images of the operational check performed on the (System). This was a basic, non-invasive visual overview only. No visible operational faults were noted at the exact time of inspection, but this does not imply compliance or long-term safety.

We are not licensed electricians; this is a simple inspection of solar fittings and fixtures. We recommend engaging a licensed electrician to investigate further for a full electrical solar audit.

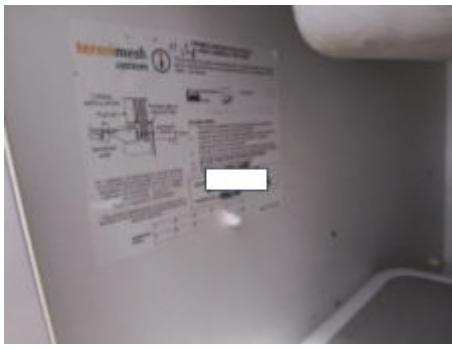
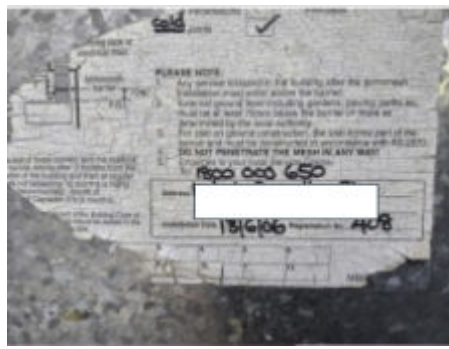
Was evidence of a previous treatment located at the time of inspection? (This may include Durable Notice/ Treatment Sticker, drill holes or baiting)	Yes
--	-----

The following evidence was found:	Treatment sticker in meter box. Treatment sticker in kitchen cupboard.
-----------------------------------	---

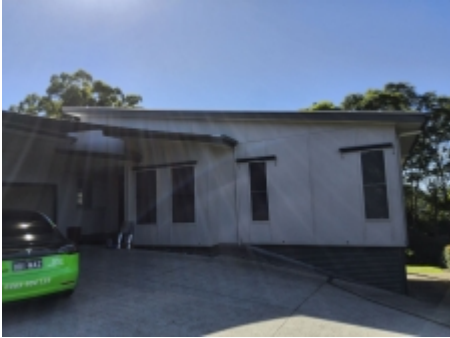
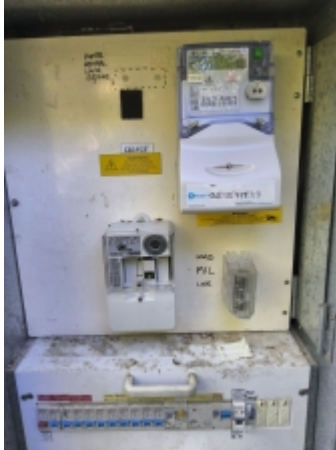
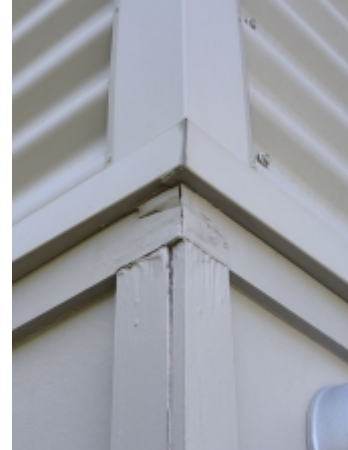
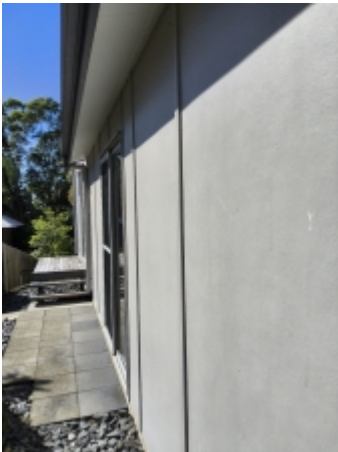
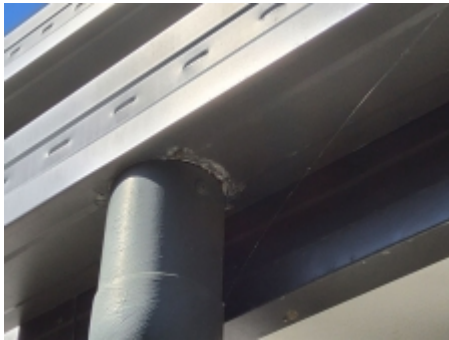
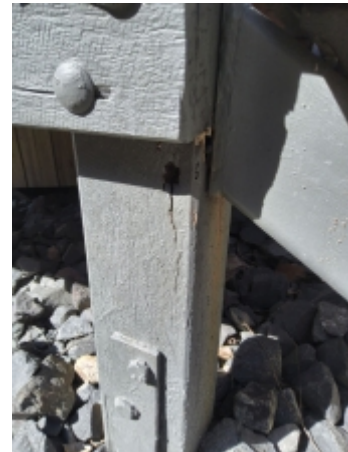
Photo Comments

Additional obstruction and general photos taken at the time of inspection.

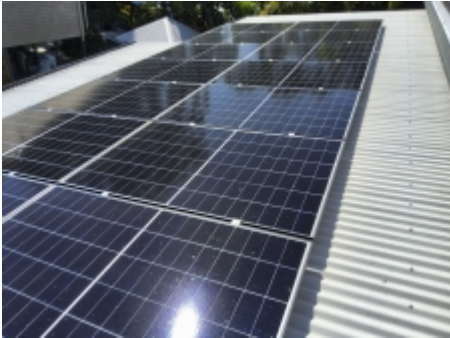
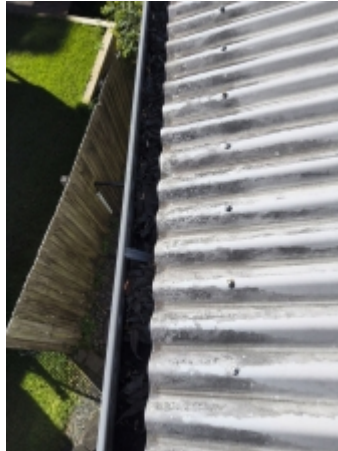
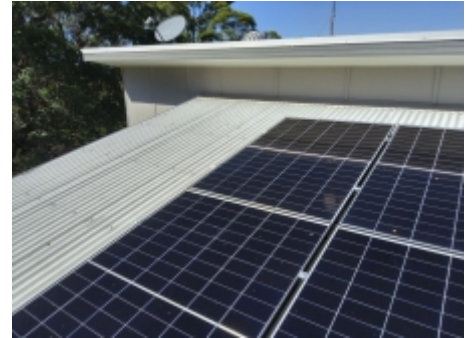
Photo Comments Additional obstruction and general photos taken at the time of inspection.

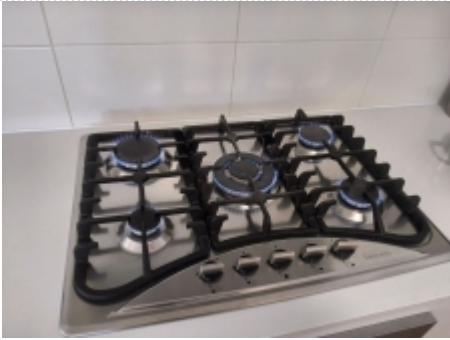
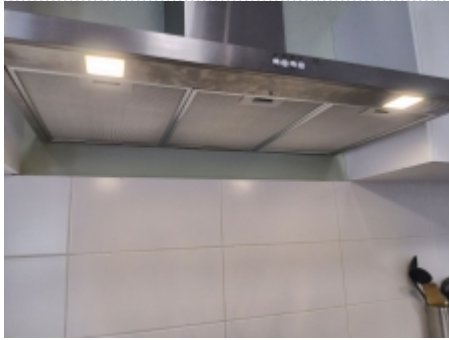
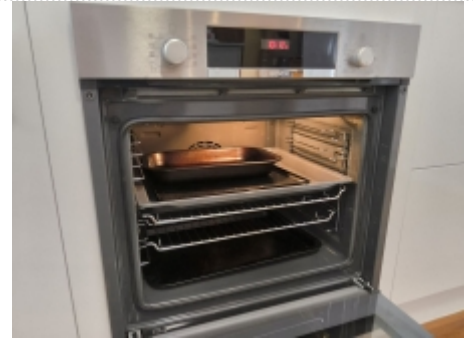
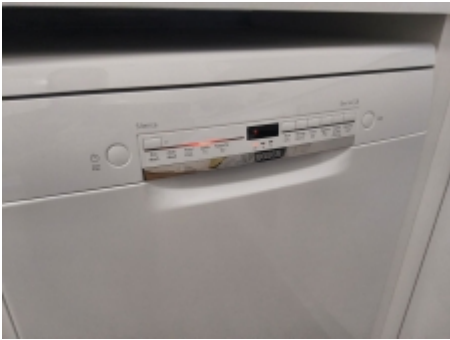
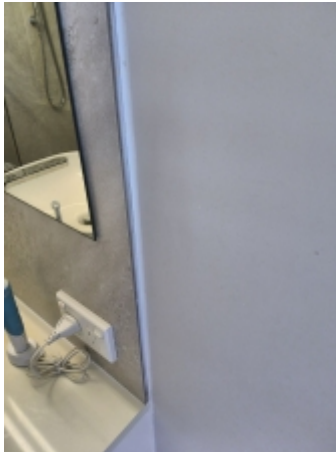
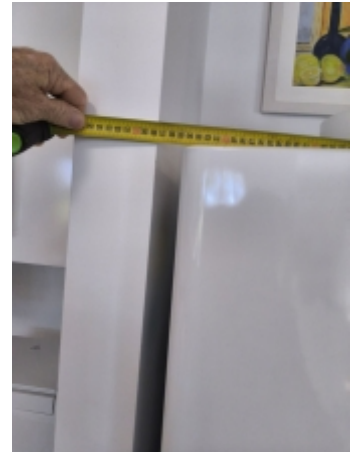
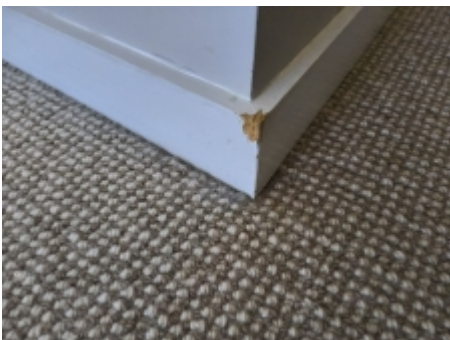
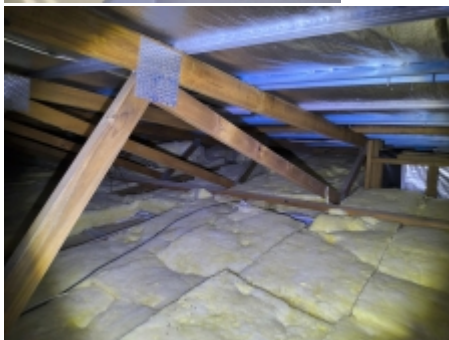
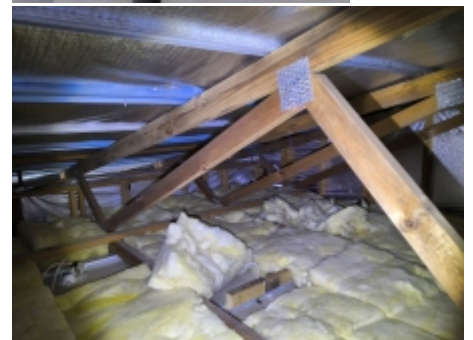
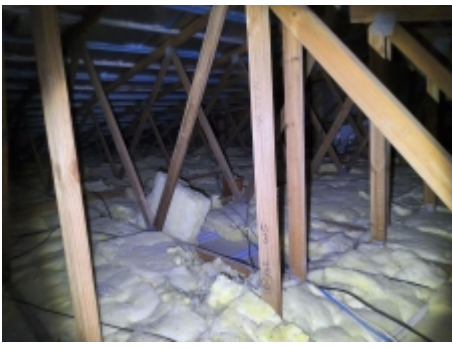
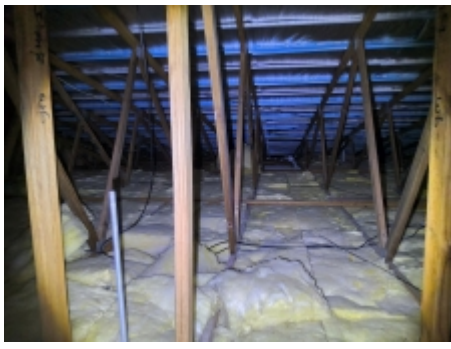
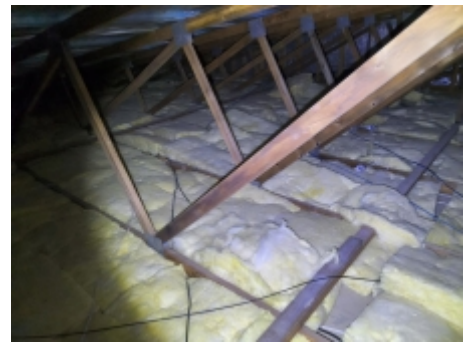
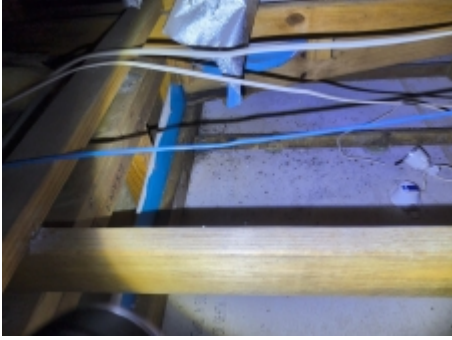
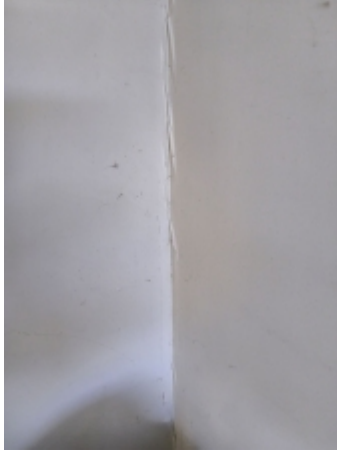
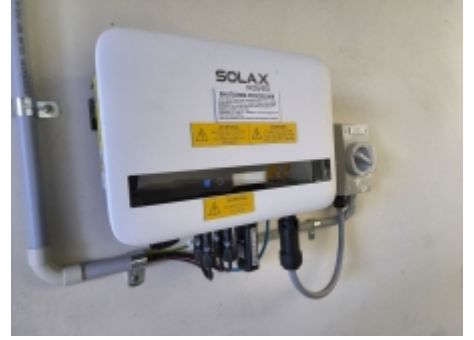
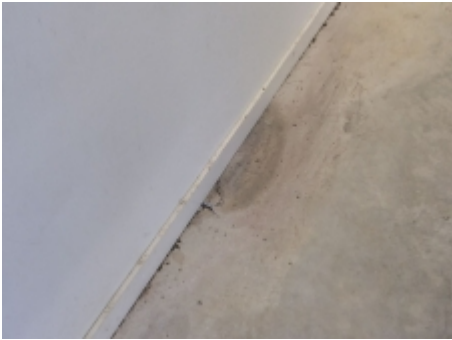
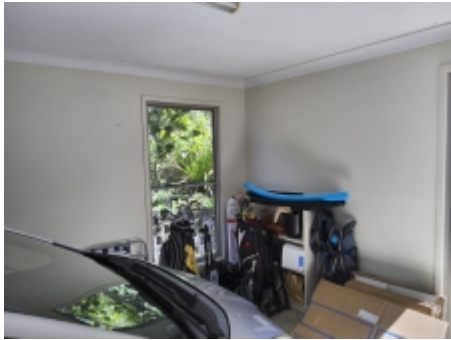
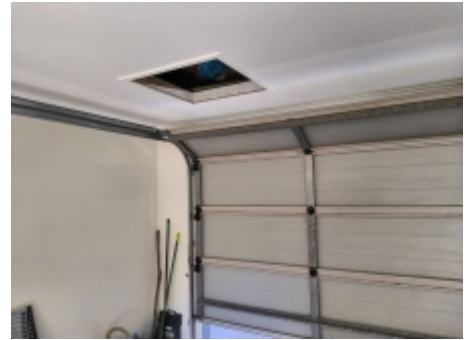
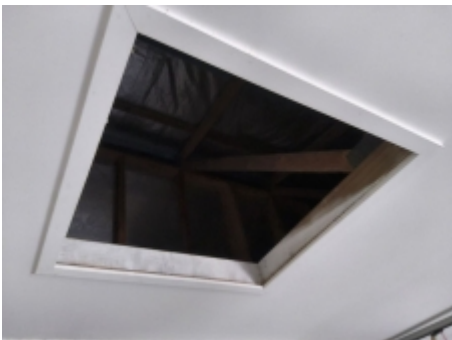
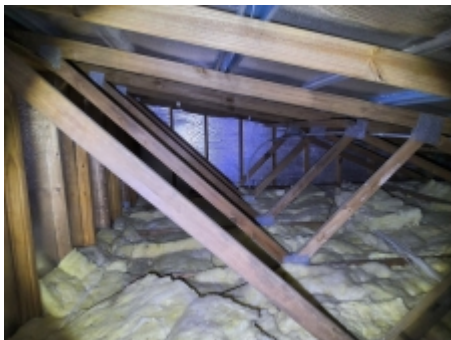
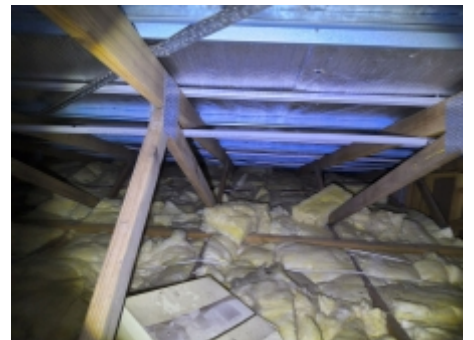
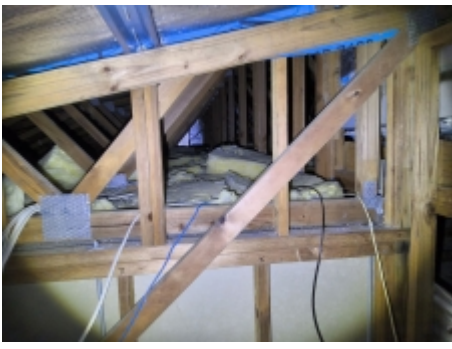
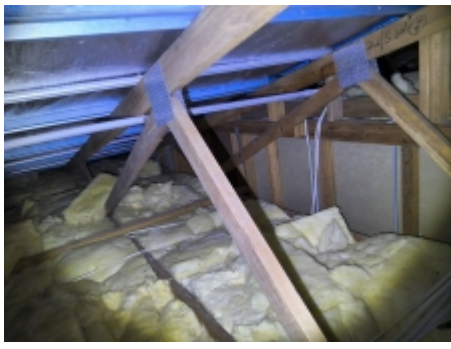
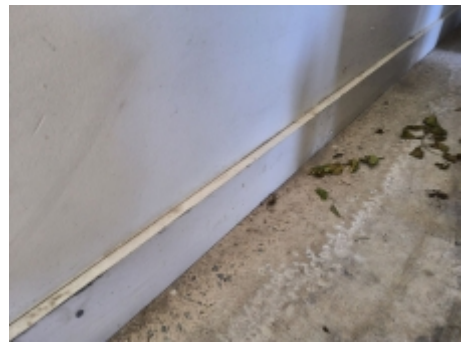
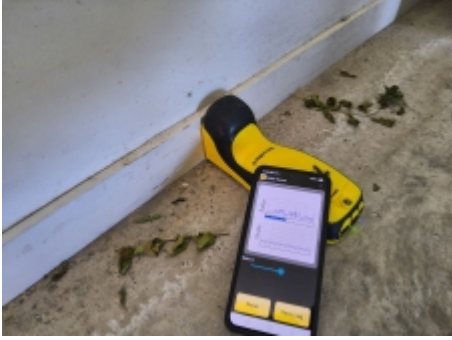
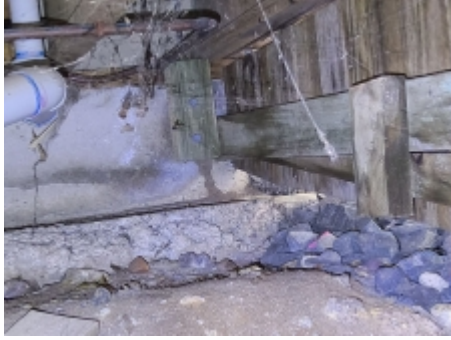
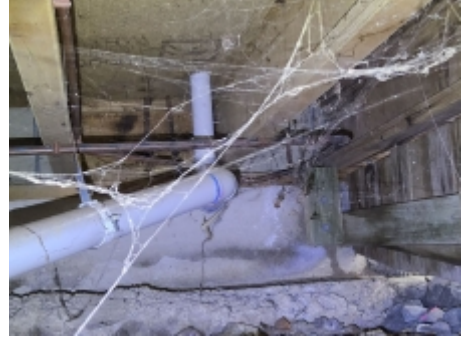
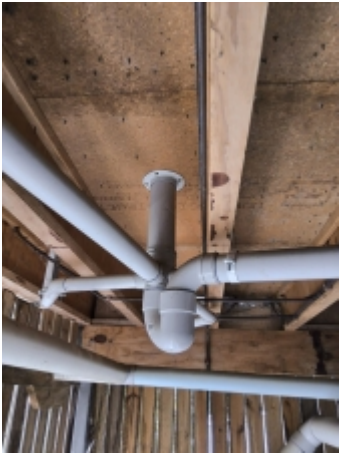
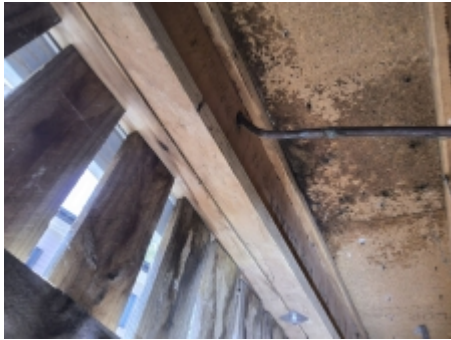
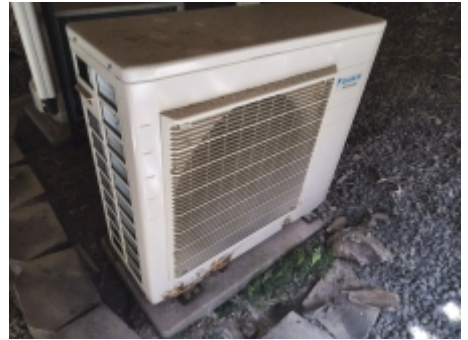
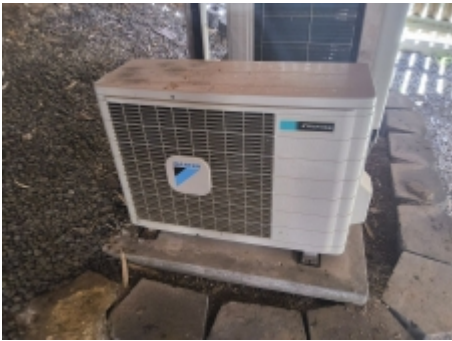
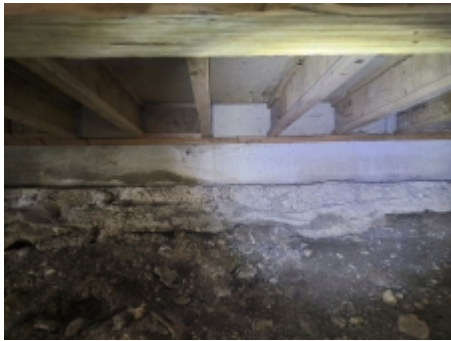
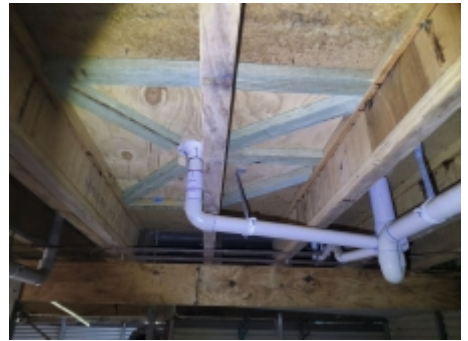
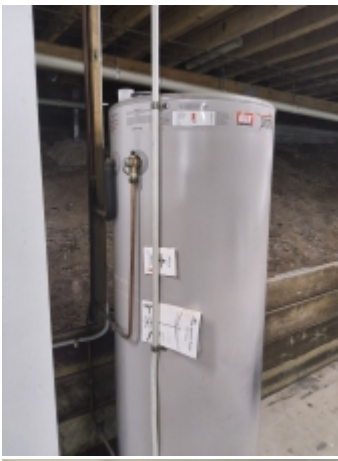
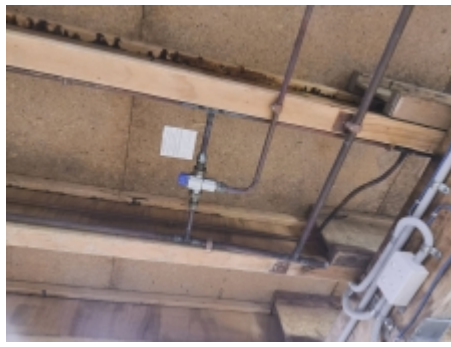
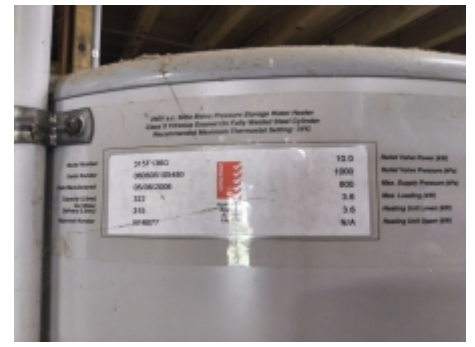
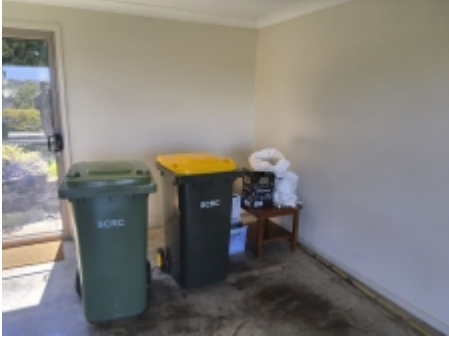
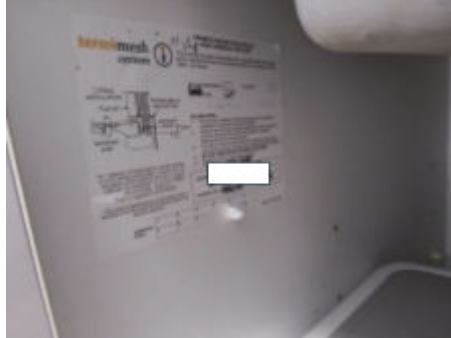
Photo Comments

Additional obstruction and general photos taken at the time of inspection.

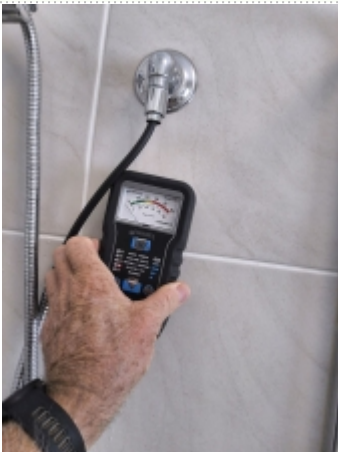
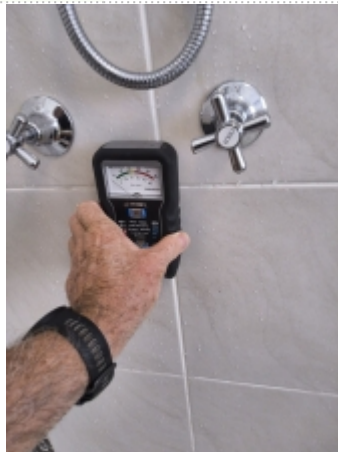
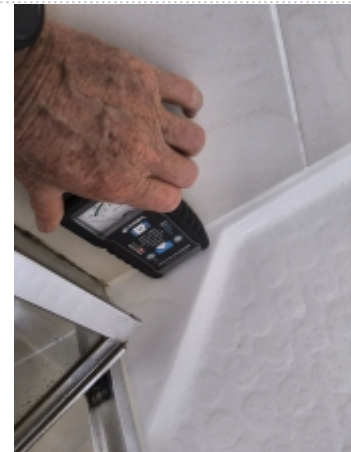
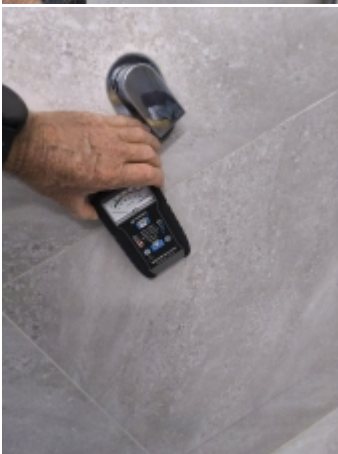
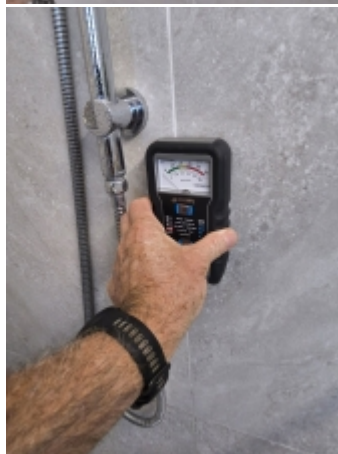
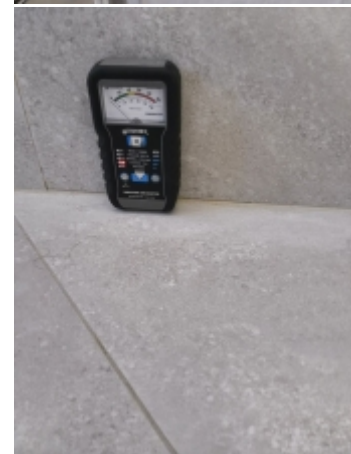
Shown example of moisture readings taken around wet areas that did not indicate elevated moisture.
